OnSight PROS Report

REPORT DATE	PROPERTY LOCATION
11/4/2017	
REPORT TYPE	PROPERTY MANAGER
Move-in

SERVICES PERFORMED	
ITEM	LOCATION
Basic Property Report	
Tenant Walkthrough & Signature

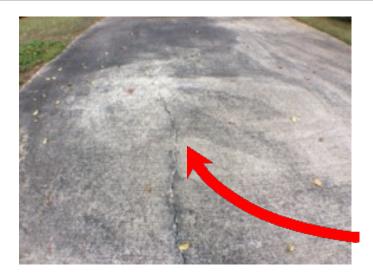
Front Exterior
Driveway
Spider cracks in driveway.

Driveway - Spider cracks in driveway.

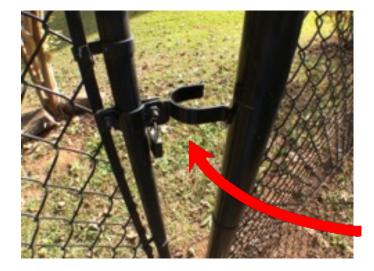
Rear Exterior
Rear Gate
Does not lock fence properly.

Rear Gate - Does not lock fence properly.

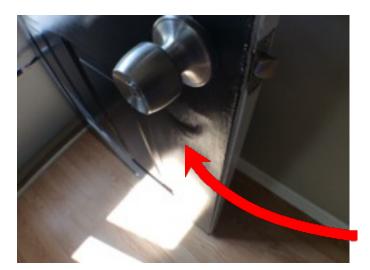
Entry
Front Door Exterior
Dent in door.

Front Door Exterior - Dent in door.

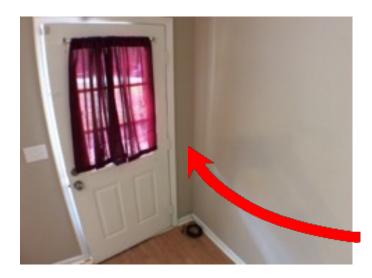
Entry
Door Stops
Missing- no wall damage noted.

Door Stops - Missing- no wall damage noted.

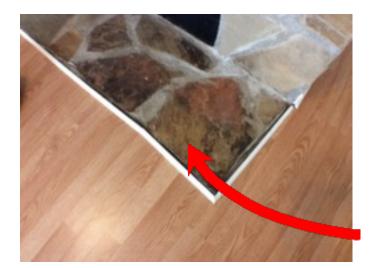
Living Room FlooringTrim on floor not even.

Flooring - Trim on floor not even.

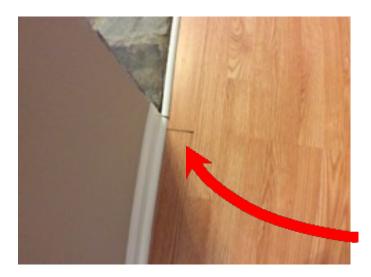
Living Room Flooring Gap in flooring

Flooring - Gap in flooring

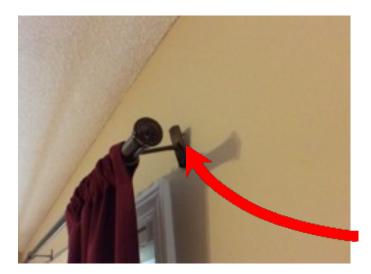
Living Room Blinds/DrapesCurtain rod pulling away.

Blinds/Drapes - Curtain rod pulling away.

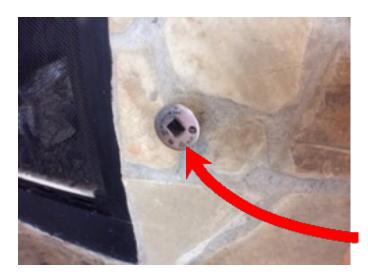
Living Room FireplaceFireplace key does not operate gas lever.

Fireplace - Fireplace key does not operate gas lever.

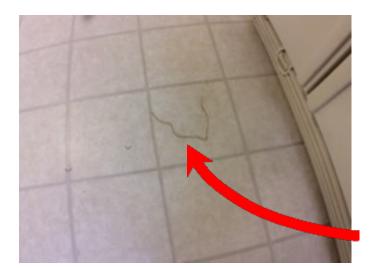
Kitchen Flooring Tear in floor.

Flooring - Tear in floor.

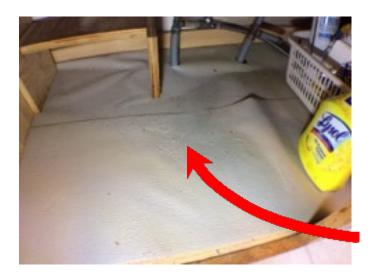
Kitchen
Cabinet Under Sink
There is moisture present.

Cabinet Under Sink - There is moisture present.

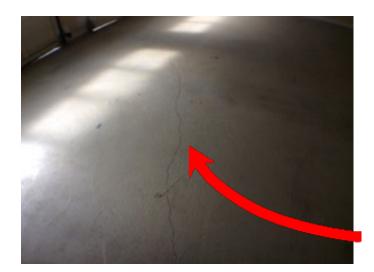
Garage Flooring Crack in flooring.

Flooring - Crack in flooring.

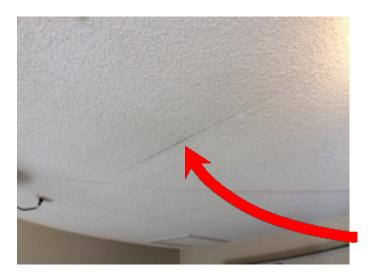
Garage Ceiling Cracks in ceiling.

Ceiling - Cracks in ceiling.

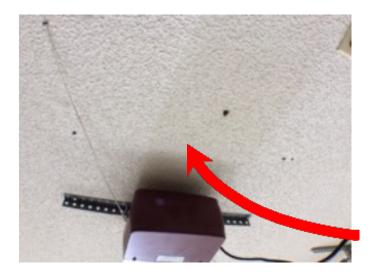
Garage
Ceiling
Holes in ceiling.

Ceiling - Holes in ceiling.

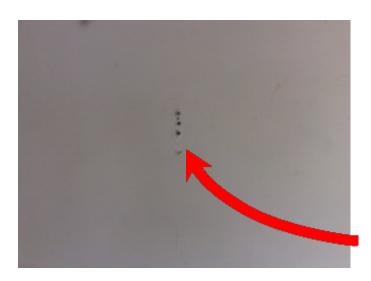
Garage Walls/Paint Holes in wall.

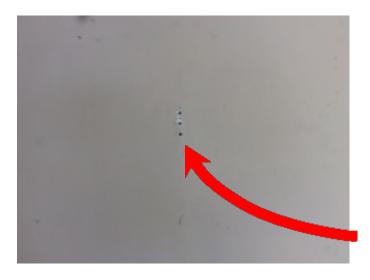
Garage Walls/Paint Holes in wall.

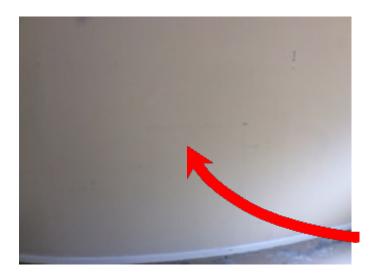
Garage Walls/Paint Marks on walls.

Walls/Paint - Marks on walls.

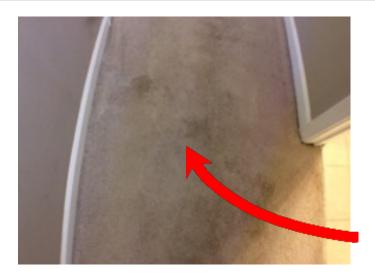
Hallway/Stairway Flooring Stains in Flooring.

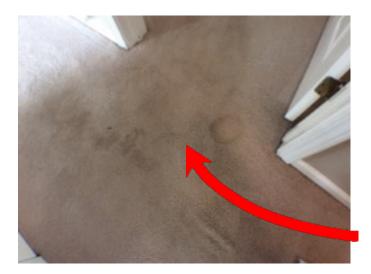
Hallway/Stairway Flooring Stains in Flooring.

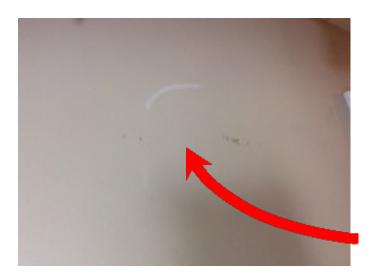
Hallway/Stairway Walls/Paint Marks on walls.

Walls/Paint - Marks on walls.

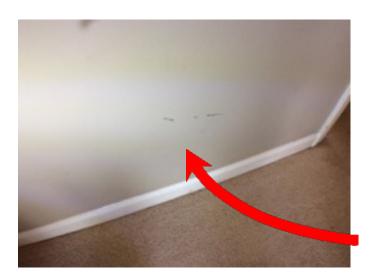
Hallway/Stairway Walls/Paint Marks on wall.

Walls/Paint - Marks on wall.

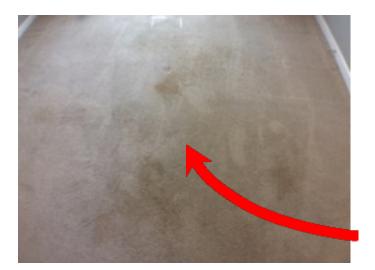
Bedroom 1 Flooring Stains in Flooring.

Flooring - Stains in Flooring.

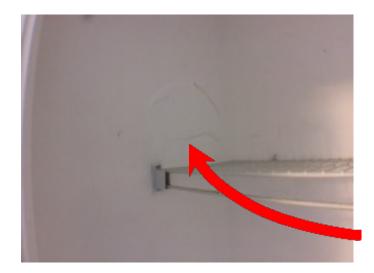
Bedroom 1
Closets
The walls are marked up.

Closets - The walls are marked up.

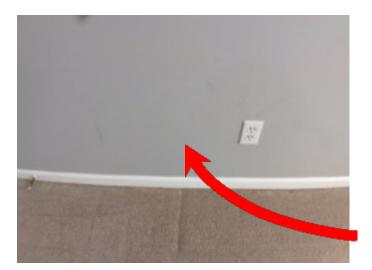
Bedroom 2 Walls/Paint Marks on wall.

Walls/Paint - Marks on wall.

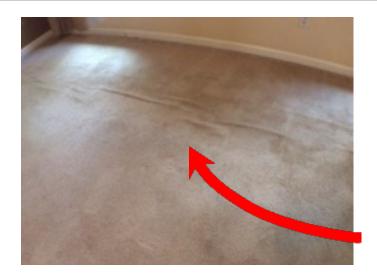
Bedroom 3
Flooring
Carpet loose.

Flooring - Carpet loose.

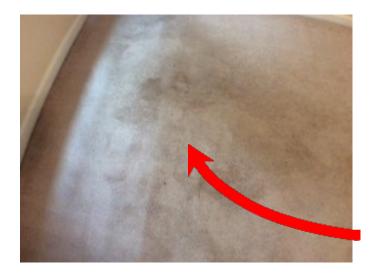
Bedroom 3 FlooringStains in Flooring.

Flooring - Stains in Flooring.

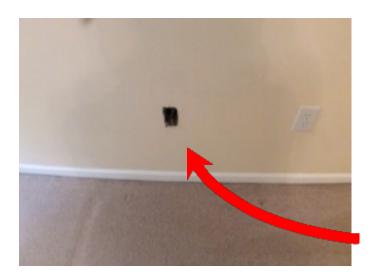
Bedroom 3
Outlet/Switch Covers
Cover is missing.

Outlet/Switch Covers - Cover is missing.

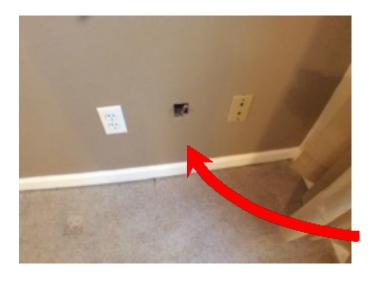
Bedroom 3
Outlet/Switch Covers
Cover is missing.

Outlet/Switch Covers - Cover is missing.

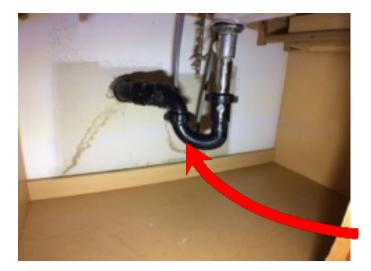
Bathroom 2
Cabinet Under Sink
Discolored rear of cabinet.

Cabinet Under Sink - Discolored rear of cabinet.

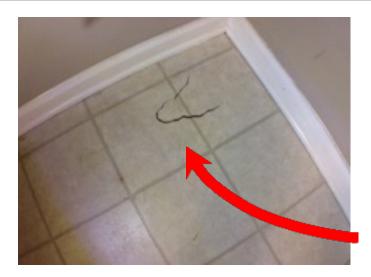
Utility Room Flooring
Tear in floor.

Flooring - Tear in floor.

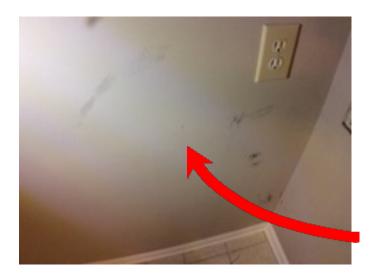
Utility Room Walls/Paint Marks on wall.

Walls/Paint - Marks on wall.

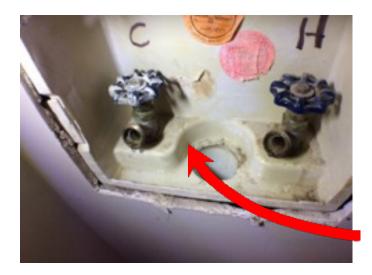
Utility Room Washer Connection Faucets were leaking.

Washer Connection - Faucets were leaking.

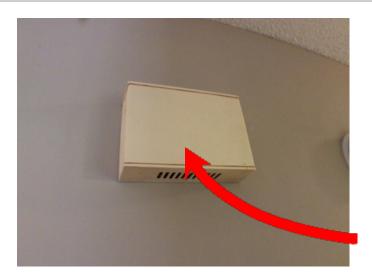
Miscellaneous Doorbell Makes a loud buzzing sound.

Doorbell - Makes a loud buzzing sound.
